**Flood Control Project Maintenance
Levee Inspections**
LMA District Cover Sheet
Spring 2018 Levee Inspection Results

Reclamation District No. 0349 Sutter Island

Spring 2018 Levee Inspection Results

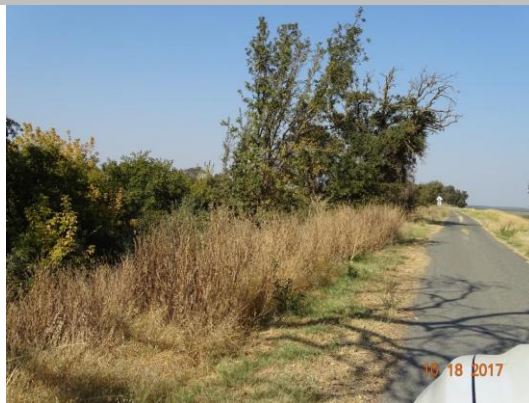
Photo 1 of 1 : SP_2018_RD0349_206_34_20180305_00005.jpg

LM Start	0.00	Rating **	M	Issue No.	34
LM End	0.81	Issue Type +	Ma	Location *	WS
Category	Earthen Levee			GPS Latitude/Longitude	
				Start	End
Item	Vegetation			38.254795 °	38.266231 °
				-121.600083 °	-121.601878 °
DWR ID	DWR_RD0349_03_f_2017_34				
Comment Code					
V1 : Control annual grass and weeds on the levee slopes and easements.					
Inspector Comment					
Waterside vegetation should be removed to 20 feet from crown to allow inspection and access.

Waterside vegetation should be removed to 20 feet from crown to allow inspection and access.

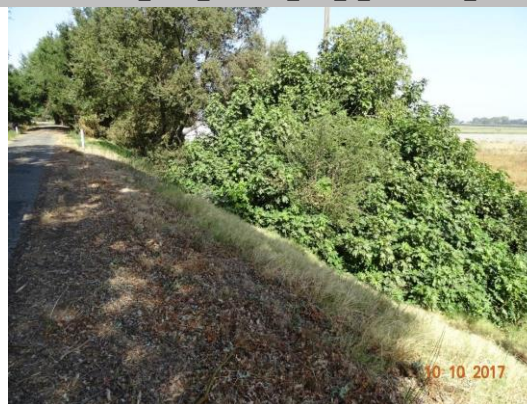
Photo 1 of 1 : SP_2018_RD0349_206_8_20180305_00001.jpg

LM Start	0.76	Rating **	U	Issue No.	8
LM End	0.76	Issue Type +	Ma	Location *	LS
Category	Earthen Levee			GPS Latitude/Longitude	
				Start	End
Item	Trim / Thin Trees			38.265637 °	38.265637 °
				-121.601640 °	-121.601640 °
DWR ID	DWR_RD0349_03_f_2017_8				
Comment Code					
T2 : Thin trees to allow visibility of the ground and room to flood fight.					
Inspector Comment					
Trim large fig tree to allow visibility and access to landside levee slope.

Trim trees on landside at LM 0.76.

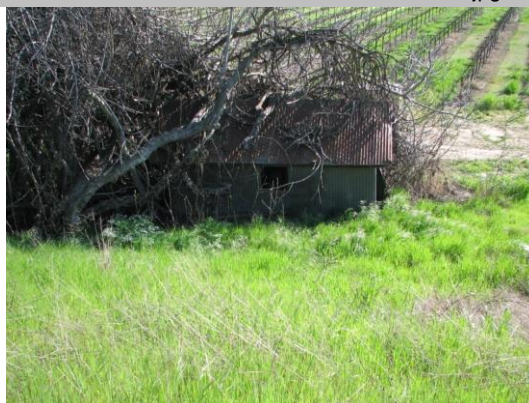
Photo 2 of 3 : UCIP_SP_2018_43442_36706.jpg

Pump house located at the landward toe.

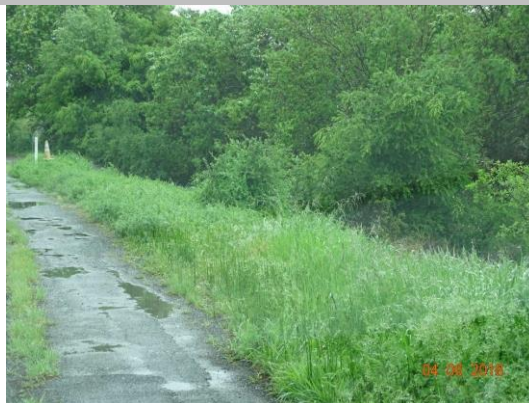
Photo 1 of 1 : SP_2018_RD0349_206_69_20180409_00090.jpg

LM Start	0.83	Rating **	U	Issue No.	69
LM End	1.07	Issue Type +	Ma	Location *	LS
Category	Earthen Levee			GPS Latitude/Longitude	
				Start	End
Item	Vegetation			38.266568 °	38.269859 °
				-121.601958 °	-121.603541 °
DWR ID	DWR_RD0349_03_s_2018_69				
Comment Code					
V2 : Remove the wild growth other than native grasses from the levee slopes.					
Inspector Comment

Manage landside vegetation to allow inspection and access.

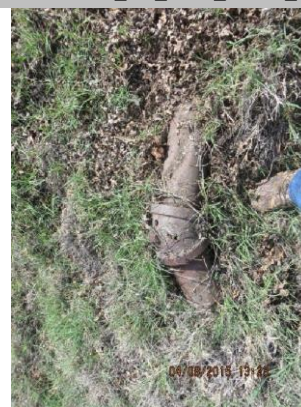
Photo 2 of 2 : UCIP_SP_2018_44335_73720.jpg

LM Start	1.17	Rating **	M	Issue No.	94
LM End	1.17	Issue Type +	En	Location *	
Category	Supplemental			GPS Latitude/Longitude	
				Start	End
Item	DWR UCIP Field Study			38.271218 °	38.271218 °
				-121.603468 °	-121.603468 °
DWR ID					
Comment Code					
Inspector Comment					
FS_ID:44335 DS_ID:24166 EP_NO: N/A Repair Type: Non-Urgent Crossing Status: Found UCIP Comments: Pipe abandoned and should be done so properly or verified as having been done so properly. FIELD_STRUCT_DESC: 6-inch irrigation pipe of unknown material through the levee, 4.5 feet below the levee crown. Pump and pump house no longer on the landside (LS) toe. [Additional Reference(s): DWR Levee Log, 2005. USACE Sacramento O&M Manual Unit No. 110, May 1959, revised 29 Dec 2016, (HLM 1.2)] FS Date: 4/9/2015

Pipe visible on LS slope.

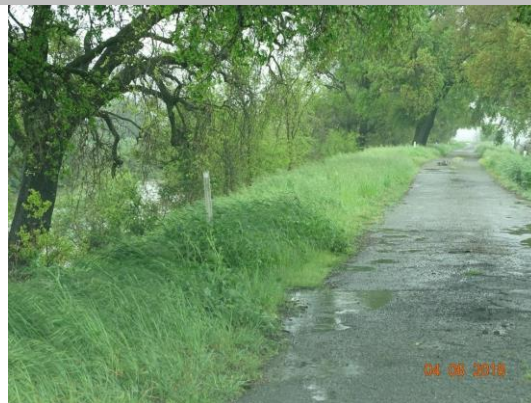
Photo 1 of 1 : SP_2018_RD0349_206_70_20180409_00091.jpg

LM Start	1.26	Rating **	U	Issue No.	70
LM End	1.49	Issue Type +	Ma	Location *	WS
Category	Earthen Levee			GPS Latitude/Longitude	
				Start	End
Item	Vegetation			38.272528 °	38.275496 °
				-121.603043 °	-121.601272 °
DWR ID	DWR_RD0349_03_s_2018_70				
Comment Code					
V2 : Remove the wild growth other than native grasses from the levee slopes.					
Inspector Comment

Waterside vegetation should be reduced to 20' from crown.

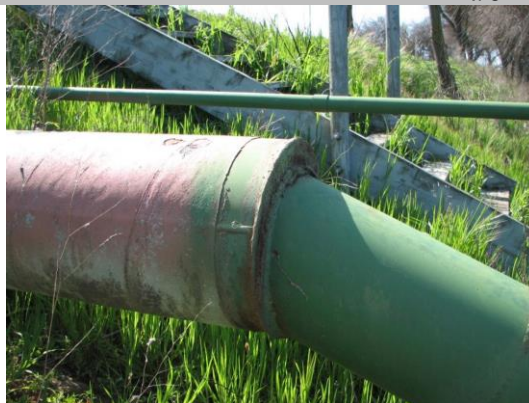
Photo 2 of 3 : UCIP_SP_2018_47042_36857.jpg

Comment Code						
Inspector Comment						
FS_ID:47042 DS_ID:24168 EP_NO: 11744 Repair Type: Non-Urgent Crossing Status: Found UCIP Comments: Dense vegetation limits the inspector's visibility to identify signs of pipe failure (leaks) through the levee slopes. Recommend removing vegetation along pipe alignment to conduct proper inspection of structure and appurtenances. Note date on photos should be 3/18/09 not 7/26/08 camera metadata is incorrect. FIELD_STRUCT_DESC: 2 of 2: 14-inch steel irrigation pipe and 2-inch electric conduit through the levee, 4.4 feet below the levee crown. Pipe section on both levee slopes reduced to 12-inch steel pipe . Steel cutoff wall around pipe at center of levee. Siphon breaker at landside (LS) shoulder. Slant pump on waterside (WS) with staircase access. Discharge structure at LS toe. Rock revetment on WS slope. (14-inch pipe through levee and 12-inch in the slopes authorized under Permit No. 11744, 1976 - J. Wiedman, also approved at different location is a 8-inch pipe) [Additional Reference(s): DWR Levee Log, 2005] FS Date: 3/19/2009

Pipe reduced from 14-inch to 10-inch and conduit through levee.

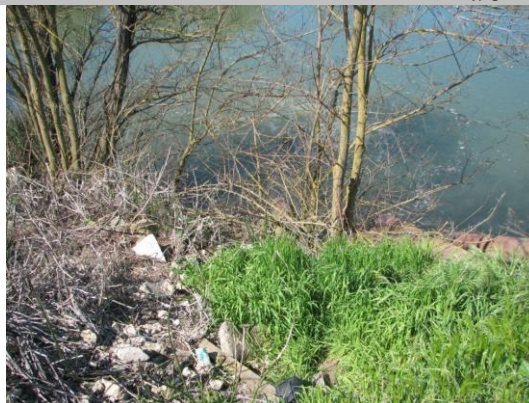
Photo 2 of 2 : UCIP_SP_2018_43446_36726.jpg

Comment Code						
Inspector Comment						
FS_ID:43446						
DS_ID:24229						
EP_NO: 2954						
Repair Type: Non-Urgent						
Crossing Status: Found						
UCIP Comments: Dense vegetation limits the inspector's visibility to identify signs of pipe failure (leaks) through the levee slopes.						
Recommend removing vegetation along pipe alignment to conduct proper inspection of structure and appurtenances. Note date on photos should be 3/18/09 not 7/26/08 camera metadata is incorrect.						
FIELD_STRUCT_DESC: [R.D. No. 349 Drainage Pumping Plant] 1 of 3: 18-inch steel drainage pipe through the levee, 7.8 feet below the crown. Siphon breakers on waterside (WS) slope. Pumps on platform on landside (LS). [Additional Reference(s): DWR Levee Log, 2005. USACE Sacramento O&M Manual Unit No. 110, May 1959, revised 29 Dec 2016, (HLM 1.6)]						
FS Date: 3/19/2009

View of all 3 pipes through levee and visible on waterward toe.

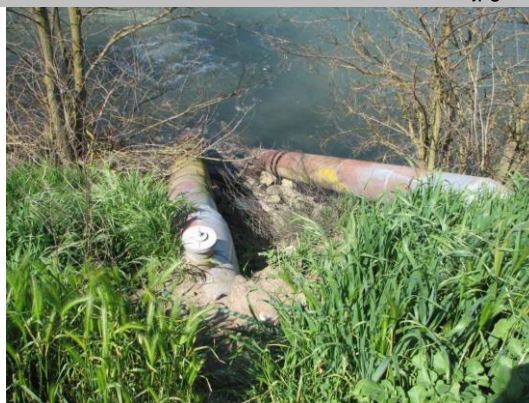
Photo 2 of 3 : UCIP_SP_2018_43445_36727.jpg

View of pipe on waterward side--pipe running. Siphon breaker visible on pipe.

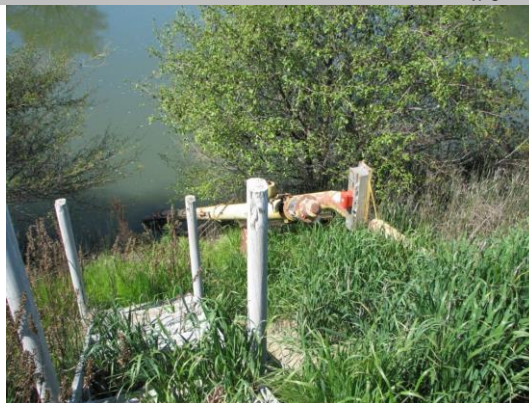
Photo 1 of 3 : UCIP_SP_2018_47045_36736.jpg

Comment Code					
Inspector Comment					
FS_ID:47045					
DS_ID:24172					
EP_NO: N/A					
Repair Type: Non-Urgent					
Crossing Status: Found					
UCIP Comments: Dense vegetation limits the inspector's visibility to identify signs of pipe failure (leaks) through the levee slopes. Recommend removing vegetation along pipe alignment to conduct proper inspection of structure and appurtenances. Note date on photos should be 3/18/09 not 7/26/08 camera metadata is incorrect.					
FIELD_STRUCT_DESC: 1 of 2: 12-inch irrigation pipe of unknown material and 2-inch electrical conduit through the levee, 8.0 feet below the levee crown. Siphon breaker in pipe riser on landside (LS) slope. Concrete standpipe at LS toe. Pump on waterside (WS) with stairway access. [Additional Reference(s): DWR Levee Log, 2005]					
FS Date: 3/19/2009

View of waterward side--pump, pipe, control panel, and stairway.

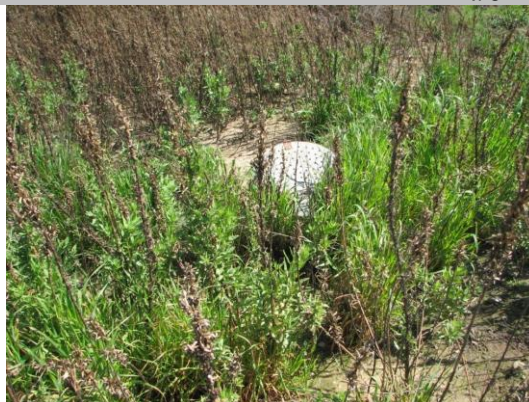
Photo 2 of 3 : UCIP_SP_2018_47045_36735.jpg

Stand pipe located on landward shoulder--pipe locked.

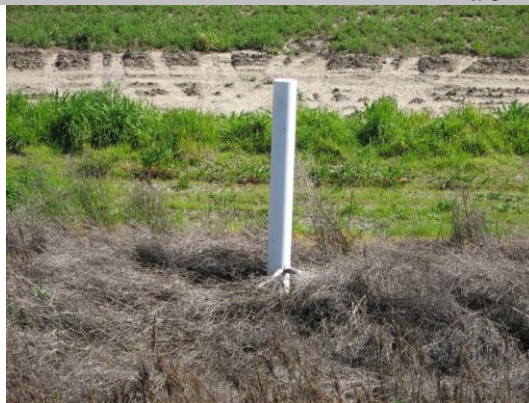
Photo 3 of 3 : UCIP_SP_2018_47045_36737.jpg

Comment Code						
Inspector Comment						
FS_ID:47045						
DS_ID:24172						
EP_NO: N/A						
Repair Type: Non-Urgent						
Crossing Status: Found						
UCIP Comments: Dense vegetation limits the inspector's visibility to identify signs of pipe failure (leaks) through the levee slopes. Recommend removing vegetation along pipe alignment to conduct proper inspection of structure and appurtenances. Note date on photos should be 3/18/09 not 7/26/08 camera metadata is incorrect. FIELD_STRUCT_DESC: 1 of 2: 12-inch irrigation pipe of unknown material and 2-inch electrical conduit through the levee, 8.0 feet below the levee crown. Siphon breaker in pipe riser on landside (LS) slope. Concrete standpipe at LS toe. Pump on waterside (WS) with stairway access. [Additional Reference(s): DWR Levee Log, 2005]						
FS Date: 3/19/2009

Tall thin stand pipe located on landward side--unable to find pipe.

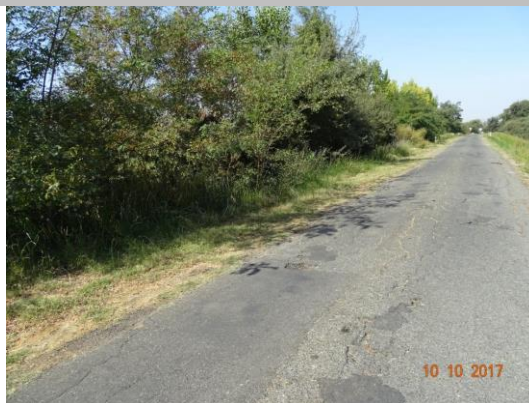
Photo 1 of 1 : SP_2018_RD0349_206_41_20180305_00010.jpg

LM Start	2.55	Rating **	U	Issue No.	41
LM End	2.74	Issue Type +	Ma	Location *	WS
Category	Earthen Levee			GPS Latitude/Longitude	
				Start	End
Item	Trim / Thin Trees			38.289420 °	38.292202 °
				-121.603321 °	-121.603669 °
DWR ID	DWR_RD0349_03_f_2017_41				
Comment Code					
T2 : Thin trees to allow visibility of the ground and room to flood fight.					
Inspector Comment

Trim trees at LM 2.84.

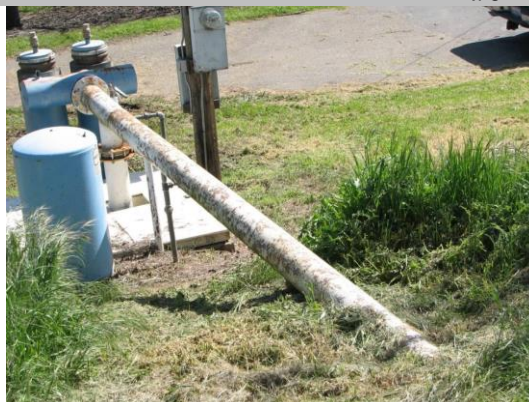
Photo 1 of 2 : UCIP_SP_2018_44390_73745.jpg

Comment Code						
Inspector Comment						
FS_ID:44390						
DS_ID:24214						
EP_NO: N/A						
Repair Type: Non-Urgent						
Crossing Status: Found						
UCIP Comments: Walway and pier abandoned and appears to be a hazard that should be removed.						
FIELD_STRUCT_DESC: 10-inch steel irrigation pipe through the levee, 5.8-feet below the levee crown. Pump, butterfly valve, and electrical panel on waterside (WS) slope. Pier and walkway next to pump on WS slope. Power pole, filters, and distribution box at landside (LS) toe.						
[Additional Reference(s): DWR Levee Log, 2005. USACE Sacramento O&M Manual Unit No. 110, May 1959, revised 29 Dec 2016, (HLM 3.5)]						
FS Date: 4/9/2015

Pipe, filter system, powerpole, and distribution box at LS toe.

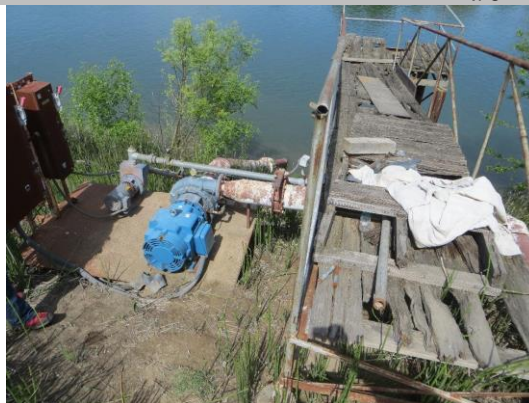
Photo 2 of 2 : UCIP_SP_2018_44390_73746.jpg

LM Start	3.34	Rating **	M	Issue No.	106 (cont)	
LM End	3.34	Issue Type +	En	Location *		
Category	Supplemental			GPS Latitude/Longitude		
				Start		End
Item	DWR UCIP Field Study			38.299718 °	38.299718 °	
				-121.601095 °	-121.601095 °	
DWR ID						
Comment Code						
Inspector Comment						
FS_ID:44390 DS_ID:24214 EP_NO: N/A Repair Type: Non-Urgent Crossing Status: Found UCIP Comments: Walway and pier abandoned and appears to be a hazard that should be removed. FIELD_STRUCT_DESC: 10-inch steel irrigation pipe through the levee, 5.8-feet below the levee crown. Pump, butterfly valve, and electrical panel on waterside (WS) slope. Pier and walkway next to pump on WS slope. Power pole, filters, and distribution box at landside (LS) toe. [Additional Reference(s): DWR Levee Log, 2005. USACE Sacramento O&M Manual Unit No. 110, May 1959, revised 29 Dec 2016, (HLM 3.5)] FS Date: 4/9/2015

Pump, electrical panel, butterfly valve, and walkway on WS slope.

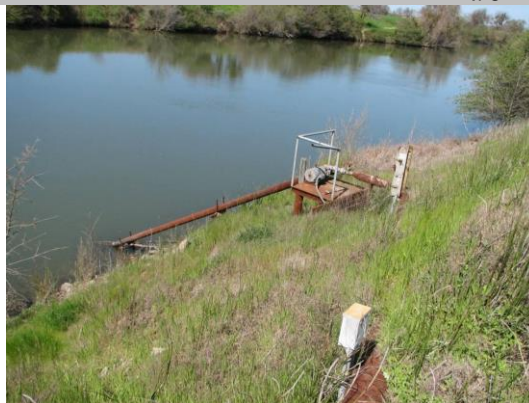
Photo 1 of 3 : UCIP_SP_2018_21644_36780.jpg

Comment Code					
Inspector Comment					
FS_ID:21644 DS_ID:24180 EP_NO: 9290 Repair Type: Non-Urgent Crossing Status: Found UCIP Comments: 03/16/2018 Levee logs indicates a 10-inch pipe present at this location however, permit records show pipe authorized and installed is 6-inch pipe. Need to field measure the WS pipe and update structure description. (DWR UCIP - O. Magana) 03/19/2009 Dense vegetation limits the inspector's visibility to identify signs of pipe failure (leaks) through the levee slopes. Recommend removing vegetation along pipe alignment to conduct proper inspection of structure and appurtenances. (DWR UCIP - O. Magana) FIELD_STRUCT_DESC: 10-inch steel irrigation pipe and 1.5-inch steel electrical conduit through the levee, 4.0 feet below the crown. Steel cutoff wall around pipe and conduit at center of levee. Pump and gate valve located on the waterside (WS) slope. 6-inch intake pipe extends from pump into channel. Distribution system at landside (LS) toe. (6-inch pipe and pump authorized under Permit No. 9290, 1975 - C. Van Loben Sels, 6-inch installed) [Additional Reference(s): DWR Levee Log, 2005] FS Date: 3/19/2009

View of waterward side.

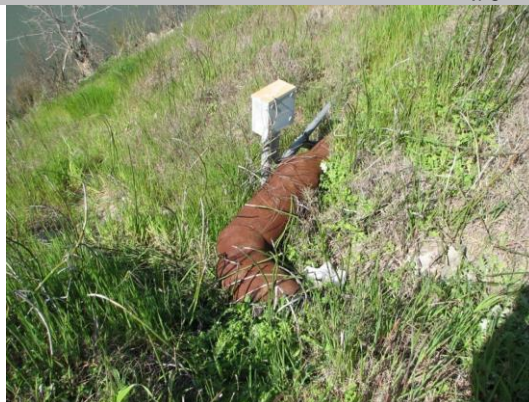
Photo 2 of 3 : UCIP_SP_2018_21644_36778.jpg

90 elbow at daylight and continues along slope and connects to pump.

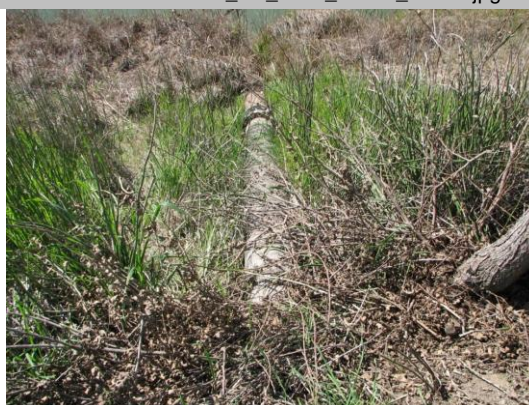
Photo 2 of 2 : UCIP_SP_2018_43455_36782.jpg

Comment Code					
Inspector Comment					
FS_ID:43455 DS_ID:24201 EP_NO: 15503 Repair Type: Non-Urgent Crossing Status: Found UCIP Comments: Dense vegetation limits the inspector's visibility to identify signs of pipe failure (leaks) through the levee slopes. Recommend removing vegetation along pipe alignment to conduct proper inspection of structure and appurtenances. Note date on photos should be 3/18/09 not 7/26/08 camera metadata is incorrect. FIELD_STRUCT_DESC: 10-inch steel irrigation pipe through the levee, 3.0 feet below the crown. Steel cutoff wall around pipe 24-inches landward of levee center. Pump and gate valve in pump house at the landside (LS) toe. Pipe is exposed along waterside (WS) slope. (10-inch pipe under Permit No. 15503, 1990 - A. Ostman, existing 10-inch removed) FS Date: 3/19/2009

View of waterward side.

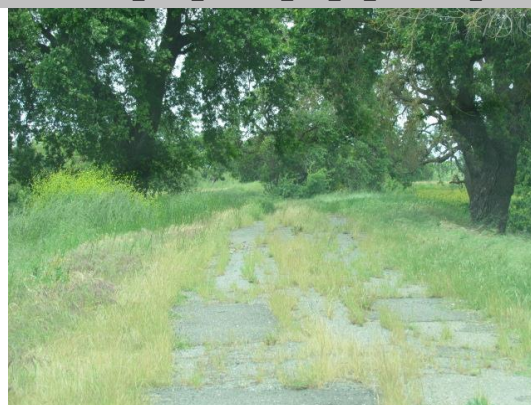
Photo 1 of 1 : SP_2018_RD0349_206_50_20180305_00014.jpg

LM Start	3.99	Rating **	M	Issue No.	50
LM End	4.91	Issue Type +	Ma	Location *	CR
Category	Earthen Levee			GPS Latitude/Longitude	
				Start	End
Item	Vegetation			38.307972 °	38.318371 °
				-121.597037 °	-121.589593 °
DWR ID	DWR_RD0349_03_s_2017_50				
Comment Code					
V9 : Keep the crown roadway free of vegetation.					
Inspector Comment					
Keep the crown roadway free of vegetation.

RD 349 Unit 4 levee mile 3.99 -6.33 crown roadway.

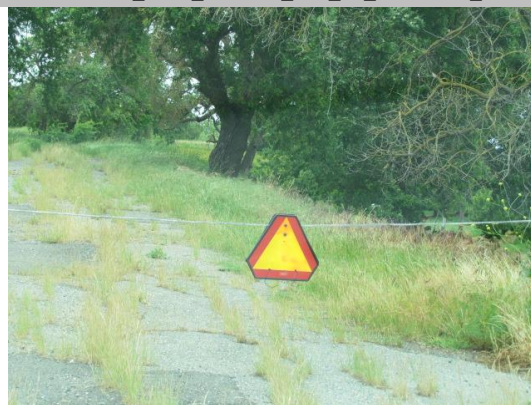
Photo 1 of 1 : SP_2018_RD0349_206_25_20180305_00003.jpg

LM Start	3.99	Rating **	U	Issue No.	25
LM End	3.99	Issue Type +	En	Location *	LS
Category	Earthen Levee			GPS Latitude/Longitude	
				Start	End
Item	Encroachments			38.307997 °	38.307997 °
				-121.597039 °	-121.597039 °
DWR ID	DWR_RD0349_03_s_2012_25				
Comment Code					
FE : Fence					
Inspector Comment					
Unauthorized cable gate crossing levee. Cable gates crossing the levee crown have been prohibited. This encroachment should be removed.

Cable crossings has been banned. They are unauthorized.

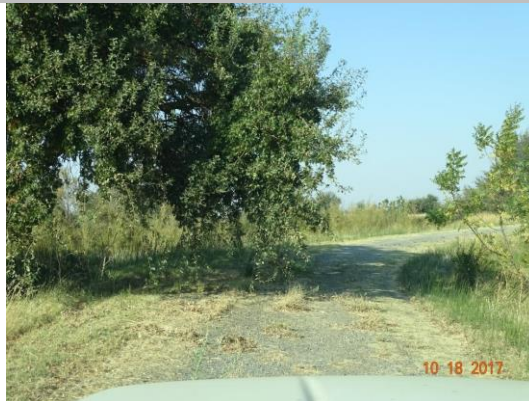
Photo 1 of 1 : SP_2018_RD0349_206_46_20180305_00011.jpg

LM Start	4.12	Rating **	M	Issue No.	46
LM End	4.12	Issue Type +	Ma	Location *	CR
Category	Earthen Levee			GPS Latitude/Longitude	
				Start	End
Item	Trim / Thin Trees			38.309669 °	38.309669 °
				-121.598068 °	-121.598068 °
DWR ID	DWR_RD0349_03_f_2017_46				
Comment Code					
T4 : Trim trees over roadway to at least 12 feet above ground level.					
Inspector Comment					
Trim trees to 12 feet above crown road.

Trim trees to 12 feet above crown road.

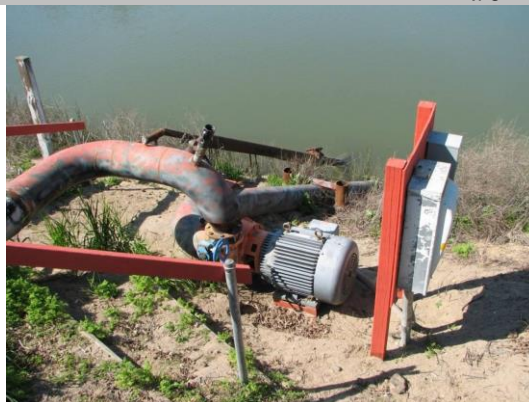
Photo 2 of 3 : UCIP_SP_2018_43457_36792.jpg

Comment Code						
Inspector Comment						
FS_ID:43457 DS_ID:24184 EP_NO: 8681 Repair Type: Non-Urgent Crossing Status: Found UCIP Comments: Need to contact owner. Is filter sytem located on landward side part of crossing. If so need permit number authorizing work. Also if crossing is no longer used by owner, the owner will need to coordinate with DWR Inspector and CVFPB to remove crossing according to Title 23 requirements. Dense vegetation limits the inspector's visibility to identify signs of pipe failure (leaks) through the levee slopes. Recommend removing vegetation along pipe alignment to conduct proper inspection of structure and appurtenances. Note date on photos should be 3/18/09 not 7/26/08 camera metadata is incorrect. FIELD_STRUCT_DESC: 2 of 2: 12-inch steel irrigation pipe through the levee, 4.3 feet below the crown. Steel cutoff wall around pipe at center of levee. Pump on platform and gate valve on the waterside (WS) slope. Exposed suction pipe from pump to channel. Rock revetment on WS slope. (12-inch and 6-inch with pump authorized under Permit No. 8681, 1973 - C. Van Loben Sels) [Additional Reference(s): DWR Levee Log, 2005] FS Date: 3/19/2009

Pump associated with 12-inch pipe.

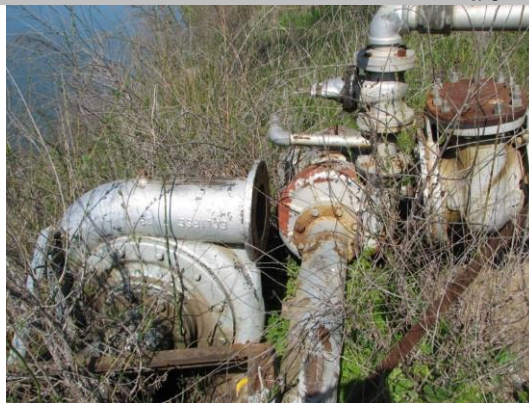
Photo 2 of 3 : UCIP_SP_2018_43459_36795.jpg

Comment Code						
Inspector Comment						
FS_ID:43459 DS_ID:24185 EP_NO: N/A Repair Type: Non-Urgent Crossing Status: Found UCIP Comments: No connection present--need to contact owner to determine if owner plans to use. If crossing is no longer in use owner will need to coordinate with DWR inspector and CVFPB to remove according to Title 23 requirements. Recommend removing vegetation along pipe alignment. Note date on photos should be 3/18/09 not 7/26/08 camera metadata is incorrect. FIELD_STRUCT_DESC: *ABANDONED* 10-inch steel irrigation pipe and 2-inch electrical conduit through the levee, both 2.8 feet below the levee crown. Abandoned pumps and gate valve on the waterside (WS) slope. Service pole on the landside (LS) slope. Concrete headwall on LS. [Additional Reference(s): DWR Levee Log, 2005. USACE Sacramento O&M Manual Unit No. 110, May 1959, revised 29 Dec 2016, (HLM 4.8)] FS Date: 3/19/2009

Pump located on waterward side is not connected.

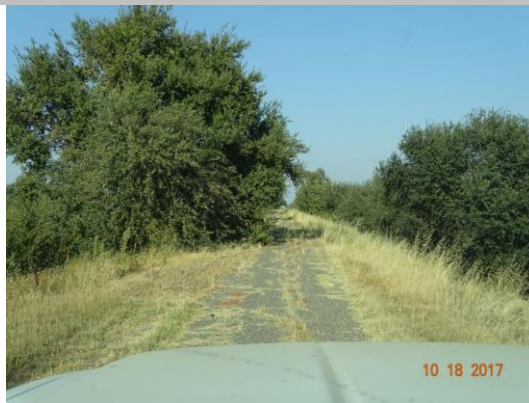
Photo 1 of 1 : SP_2018_RD0349_206_53_20180305_00015.jpg

LM Start	4.71	Rating **	M	Issue No.	53
LM End	4.71	Issue Type +	Ma	Location *	WS
Category	Earthen Levee			GPS Latitude/Longitude	
				Start	End
Item	Trim / Thin Trees			38.315813 °	38.315813 °
				-121.590960 °	-121.590960 °
DWR ID	DWR_RD0349_03_f_2017_53				
Comment Code					
T4 : Trim trees over roadway to at least 12 feet above ground level.					
Inspector Comment					
Trim tree to 12 feet above crown road, also remove low branch on waterside sholder.

Trim trees to 12 feet above crown road.

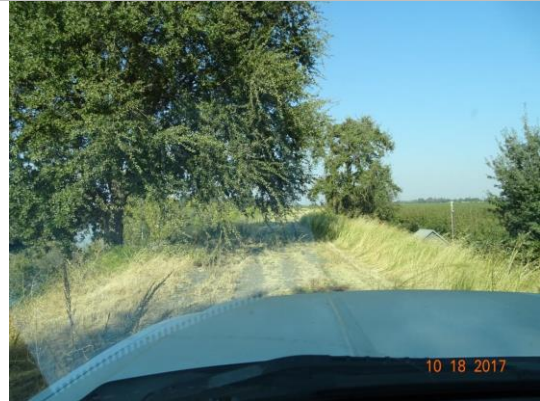
Photo 1 of 1 : SP_2018_RD0349_206_56_20180305_00017.jpg

LM Start	4.79	Rating **	M	Issue No.	56
LM End	4.79	Issue Type +	Ma	Location *	CR
Category	Earthen Levee			GPS Latitude/Longitude	
				Start	End
Item	Trim / Thin Trees			38.316767 °	38.316767 °
				-121.590391 °	-121.590391 °
DWR ID	DWR_RD0349_03_f_2017_56				
Comment Code					
T4 : Trim trees over roadway to at least 12 feet above ground level.					
Inspector Comment					
Trim trees to 12 feet above levee crown.

Trim trees to 12 feet above levee crown.

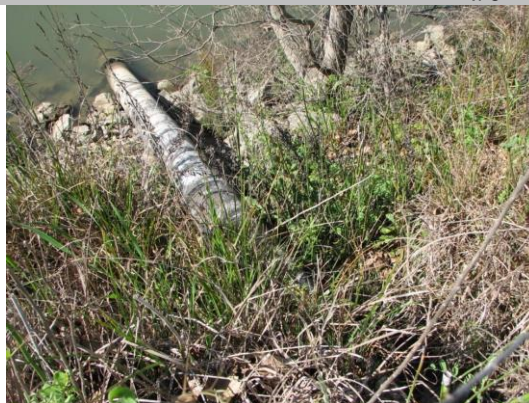
Photo 2 of 3 : UCIP_SP_2018_43431_36801.jpg

Comment Code						
Inspector Comment						
FS_ID:43431 DS_ID:24186 EP_NO: 15359 Repair Type: Non-Urgent Crossing Status: Found UCIP Comments: Dense vegetation limits the inspector's visibility to identify signs of pipe failure (leaks) through the levee slopes. Recommend removing vegetation along pipe alignment to conduct proper inspection of structure and appurtenances. Note date on photos should be 3/18/09 not 7/26/08 camera metadata is incorrect. FIELD_STRUCT_DESC: 10-inch steel irrigation pipe sleeved through a 12-inch conductor pipe through the levee, 6.0 feet below the levee crown. Siphon breaker in protective house at levee shoulder. Pump in pump house and power pole at landside (LS) toe. Pipe connected to 8-inch exposed pipe at LS shoulder, extending to pump house. Filter screen in channel at waterside (WS) toe. (existing 4-inch pipe removed and new 10-inch sleeved through 12-inch installed under Permit No. 15359, 1990 - E. Delta Orchards) [Additional Reference(s): DWR Levee Log, 2005] FS Date: 3/19/2009

Pipe located on waterward side.

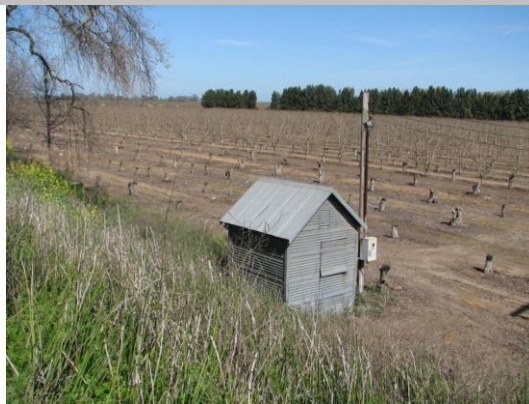
Photo 3 of 3 : UCIP_SP_2018_43431_36798.jpg

View of landward side.

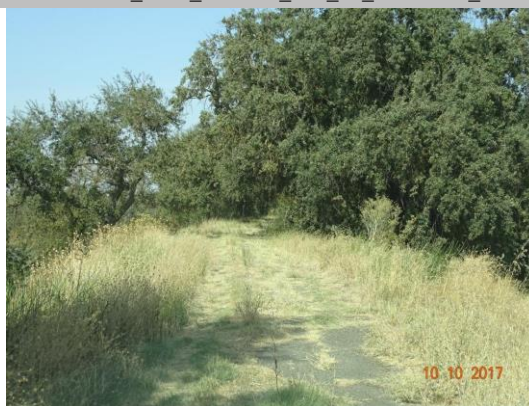
Photo 1 of 1 : SP_2018_RD0349_206_47_20180305_00012.jpg

LM Start	4.91	Rating **	M	Issue No.	47
LM End	5.59	Issue Type +	Ma	Location *	CR
Category	Earthen Levee			GPS Latitude/Longitude	
				Start	End
Item	Vegetation			38.318371 °	38.326229 °
				-121.589593 °	-121.584754 °
DWR ID	DWR_RD0349_03_f_2017_47				
Comment Code					
V9 : Keep the crown roadway free of vegetation.					
Inspector Comment

Crown vegetation at LM 4.92.

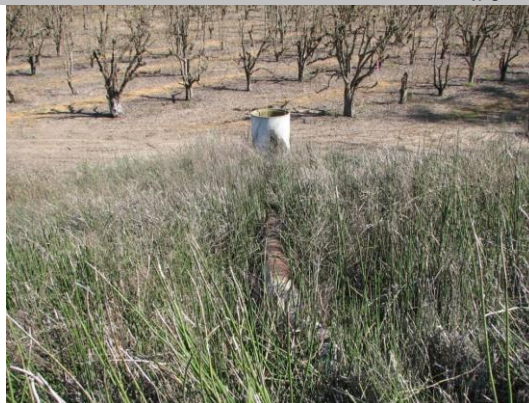
Photo 1 of 2 : UCIP_SP_2018_43433_70484.jpg

Comment Code						
Inspector Comment						
FS_ID:43433						
DS_ID:24188						
EP_NO: N/A						
Repair Type: Non-Urgent						
Crossing Status: Found						
UCIP Comments: Walkway is no longer functional. Need to contact owner--if crossing is no longer used owner will need to coordinate with DWR Inspector and CVFPB. Dense vegetation limits the inspector's visibility to identify signs of pipe failure (leaks) through the levee slopes. Recommend removing vegetation along pipe alignment to conduct proper inspection of structure and appurtenances. Note date on photos should be 3/18/09 not 7/26/08 camera metadata is incorrect.						
FIELD_STRUCT_DESC: 12-inch irrigation pipe of unknown material through the levee, 6.2 feet below the crown. Pump and control panel on piling structure in stream, with walkway. Service pole and concrete standpipe on the landside (LS) slope. [Additional Reference(s): DWR Levee Log, 2005. USACE Sacramento O&M Manual Unit No. 110, May 1959, revised 29 Dec 2016, (HLM 5.5)]

View of landward side--pipe and stand pipe visible.

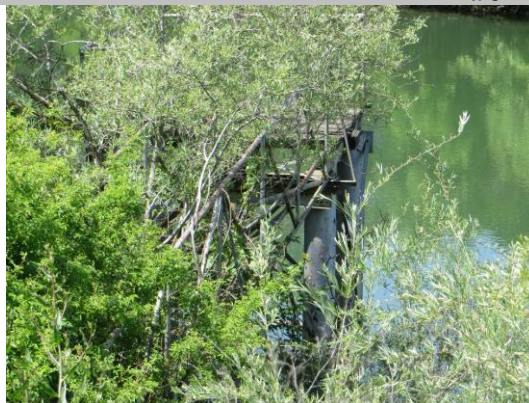
Photo 3 of 3 : UCIP_SP_2018_44391_73747.jpg

LM Start	5.19	Rating **	M	Issue No.	116 (cont)	
LM End	5.19	Issue Type +	En	Location *		
Category	Supplemental			GPS Latitude/Longitude		
				Start	End	
Item	DWR UCIP Field Study			38.322460 °	38.322460 °	
				-121.589690 °	-121.589690 °	
DWR ID						
Comment Code						
Inspector Comment						
FS_ID:44391 DS_ID:24189 EP_NO: N/A Repair Type: Non-Urgent Crossing Status: Found UCIP Comments: Appears abandoned and if so should be done so properly. FIELD_STRUCT_DESC: 4-inch irrigation pipe of unknown material through the levee, 3.3 feet below the crown. Gate and pump on platform at the landside (LS) toe (missing). Platform on the waterside (WS). [Additional Reference(s): DWR Levee Log, 2005. USACE Sacramento O&M Manual Unit No. 110, May 1959, revised 29 Dec 2016, (HLM 5.6)] FS Date: 4/9/2015

Pier on WS toe.

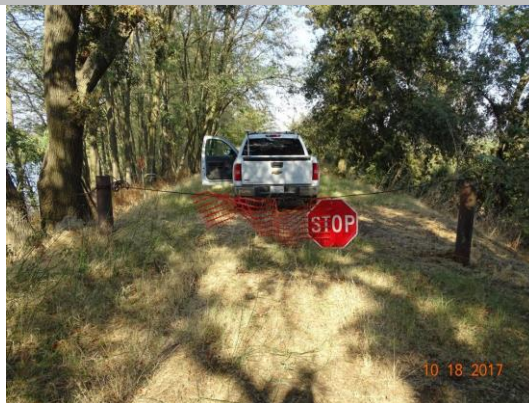
Photo 1 of 1 : SP_2018_RD0349_206_21_20180305_00002.jpg

LM Start	5.39	Rating **	U	Issue No.	21
LM End	5.39	Issue Type +	En	Location *	CR
Category	Earthen Levee			GPS Latitude/Longitude	
				Start	End
Item	Encroachments			38.323659 °	38.323659 °
				-121.586421 °	-121.586421 °
DWR ID	DWR_RD0349_03_f_2017_21				
Comment Code					
FE : Fence					
Inspector Comment					
Cable gates are banned. Must remove. No lock on this gate.

Cable gates are banned. Must remove. No lock on this gate.

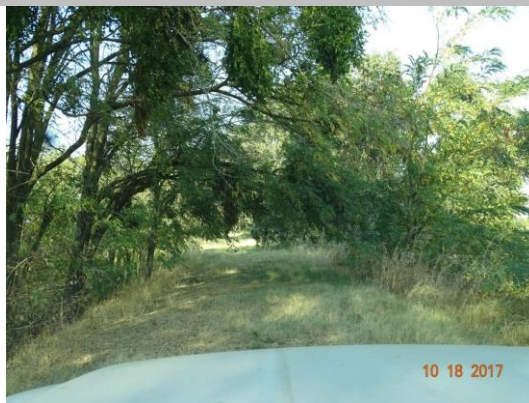
Photo 1 of 1 : SP_2018_RD0349_206_60_20180305_00018.jpg

LM Start	5.40	Rating **	M	Issue No.	60
LM End	5.42	Issue Type +	Ma	Location *	CR
Category	Earthen Levee			GPS Latitude/Longitude	
				Start	End
Item	Trim / Thin Trees			38.323767 °	38.323966 °
				-121.586269 °	-121.586029 °
DWR ID	DWR_RD0349_03_f_2017_60				
Comment Code					
T4 : Trim trees over roadway to at least 12 feet above ground level.					
Inspector Comment					
Trim trees to 12 feet above levee crown.

Trim trees to 12 feet above levee crown.

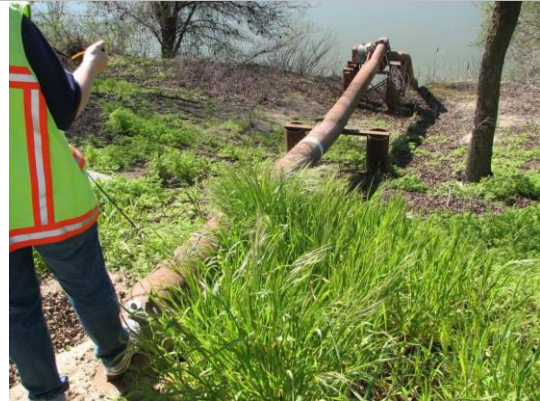
Photo 3 of 3 : UCIP_SP_2018_50016_36842.jpg

View of WS.

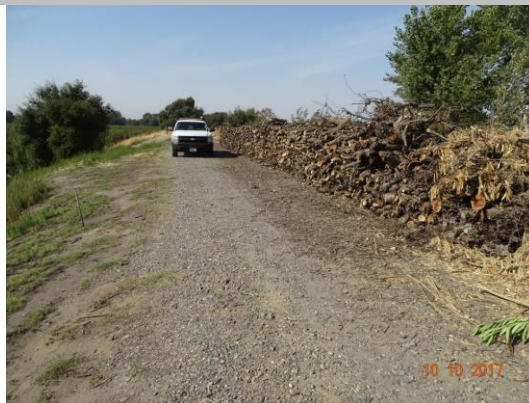
Photo 1 of 1 : SP_2018_RD0349_206_36_20180305_00007.jpg

LM Start	6.33	Rating **	U	Issue No.	36
LM End	6.35	Issue Type +	En	Location *	CR
Category	Earthen Levee			GPS Latitude/Longitude	
				Start	End
Item	Encroachments			38.328844 °	38.328626 °
				-121.579075 °	-121.578783 °
DWR ID	DWR_RD0349_03_f_2017_36				
Comment Code					
FW : Firewood					
Inspector Comment					
130-foot-long, 6-foot-high stack of firewood on waterside of crown will inhibit ability to flood fight. Should be removed.

Firewood on crown/waterside shoulder at LM 6.35.
